**BOARD OF ARCHITECTURAL REVIEW  
REGULAR MEETING**

Wednesday, September 9, 2026 @ 7:00 PM  
Town Hall – 2nd Floor, East Conference Room

- A. COA Application #2600442 - A Certificate of Appropriateness (COA) Application submitted by William H. Biggs to address the deteriorated freight elevator overrun penthouse located on the roof of 500 E. Main Street.
- B. COA Application #2600466 — A Certificate of Appropriateness (COA) Application submitted by Hyo K. Bang to retain the existing 6-over-6 vinyl windows and reconstruct a front porch with a hip roof extending over the primary entrance and front windows.

| <b>PROJECT:</b> The Mill – Structural Condition Assessment<br><br><b>LOCATION:</b> 500 East Main Street<br>Front Royal, VA<br><br><b>OWNER:</b> The Mill<br><br><b>SITE VISIT BY:</b> David Linton, PE, Linton Engineering (LE) | | |

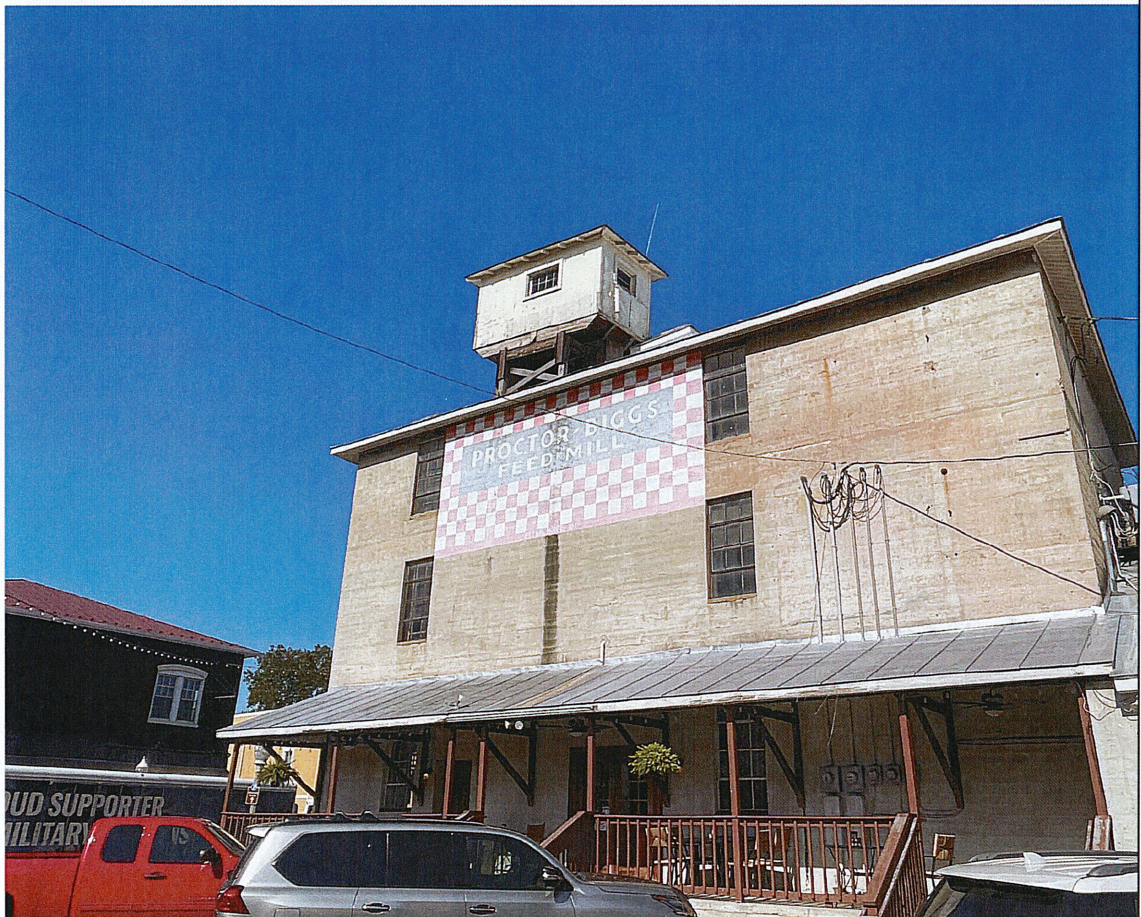
**Photo 1 – Existing Penthouse tilting away from the street**

| <b>OBSERVATIONS/ DISCUSSIONS</b><br><br><p>LE/B&amp;P visited the site to conduct a survey and structural evaluation to assess the condition of the existing freight elevator overrun penthouse.</p> <ol style="list-style-type: none"> <li>1. When looking at the side of the building from the parking lot below, there is a significant skew evident along the base of the penthouse structure sloping away from Main Street toward the rear of the property. See Photo #1.</li> <li>2. It appears that an attempt was made to add steel channels on to the face of the wood posts which cantilever above the roof to support the base of the penthouse structure, but these members are no longer connected and were not effective. Wood cross-bracing has also been installed. See Photo #2.</li> </ol> | | |

1. It appears that the rot of the wood members supporting the base of the penthouse has become extensive which has compromised the entire penthouse structure causing it to tilt toward the rear of the building. The presence of the elevator motor at the rear of the penthouse floor has likely contributed to this.

4. The recommended remedial scheme is to remove the existing penthouse from the roof, inspect the supporting penthouse structure, remove, repair, strengthen and/or replace the supporting beams and posts as needed. Once the base of the structure has been fully restored, a new penthouse structure that matches the size and appearance of the existing penthouse can then be constructed and craned on top of the strengthened base structure.

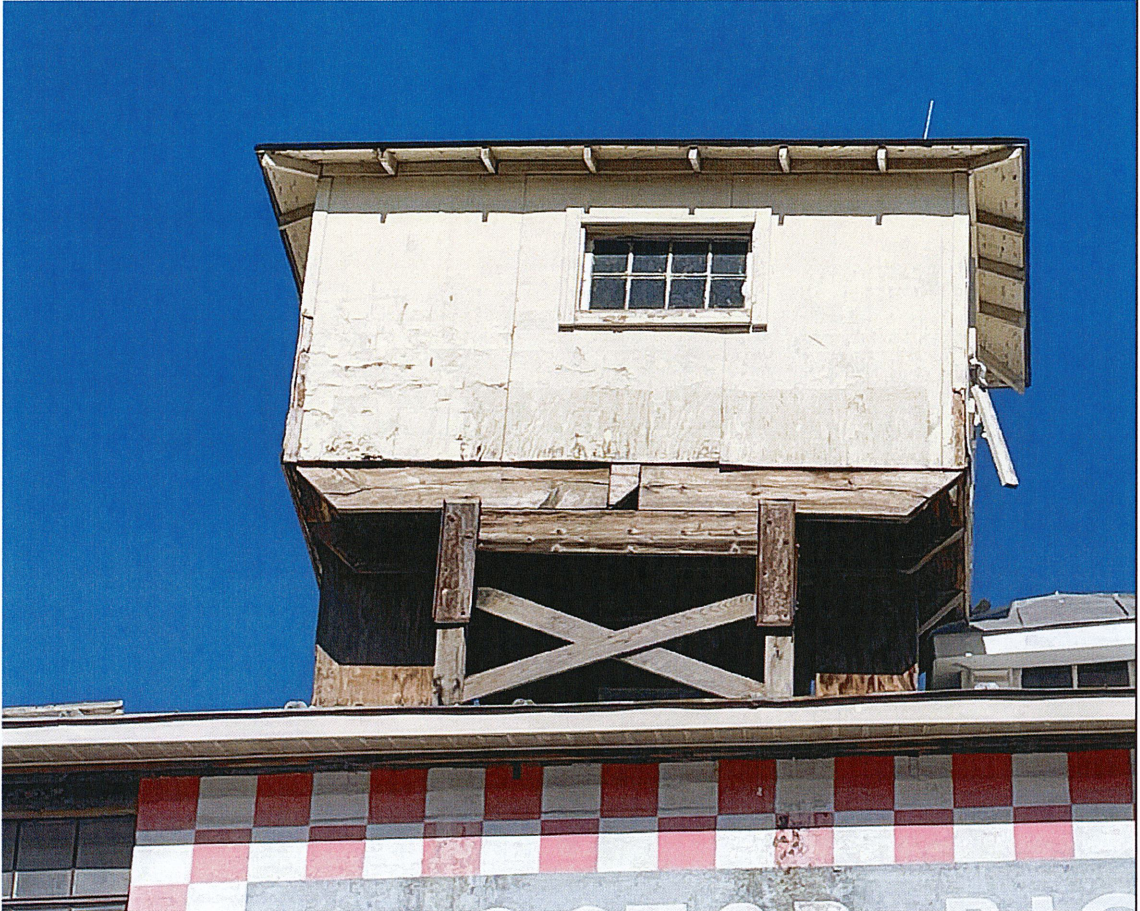
**Photo 2 – Ineffective steel channel braces**

2. The previously installed repairs using steel channels and wood cross bracing have not been effective in stabilizing the penthouse.
3. The penthouse has become a life-safety issue in its present condition and needs to be safely removed and reconstructed. The structure is past the point of being able to be stabilized in place and it would not be safe perform work on the structure without shoring and re-supporting the entire structure in-place , which is not feasible to achieve.

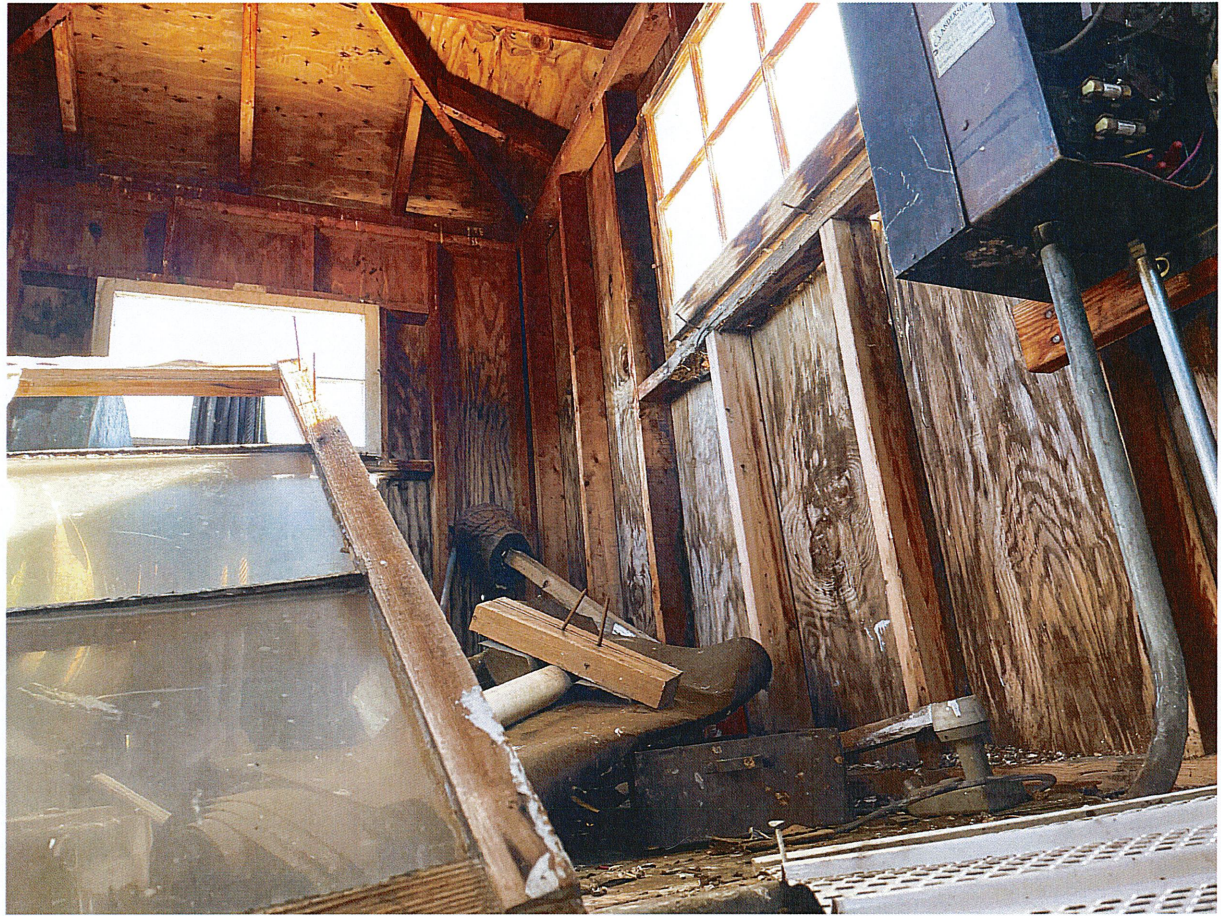
Photo 3 – Damaged Penthouse Floor Structure

3. A significant amount of wood rot was observed at the wood base structure of the penthouse which was observed via a small slit through the ladder shaft that leads to the penthouse floor. (Could not be photographed). Both the beams and supporting posts show signs of rot. The penthouse floorboards are very soft as well.
4. The penthouse floor structure has started to rot and is filled with debris. See Photo #3. The motor for the elevator is located toward the rear side of the penthouse that is sloped downward.
